# SEISMIC EVALUATION OF COMBINED FABRIC LIMITED (CFL) – MAIN BUILDING

January 2019

DEPARTMENT OF EARTHQUAKE ENGINEERING  
NED UNIVERSITY OF ENGINEERING AND TECHNOLOGY

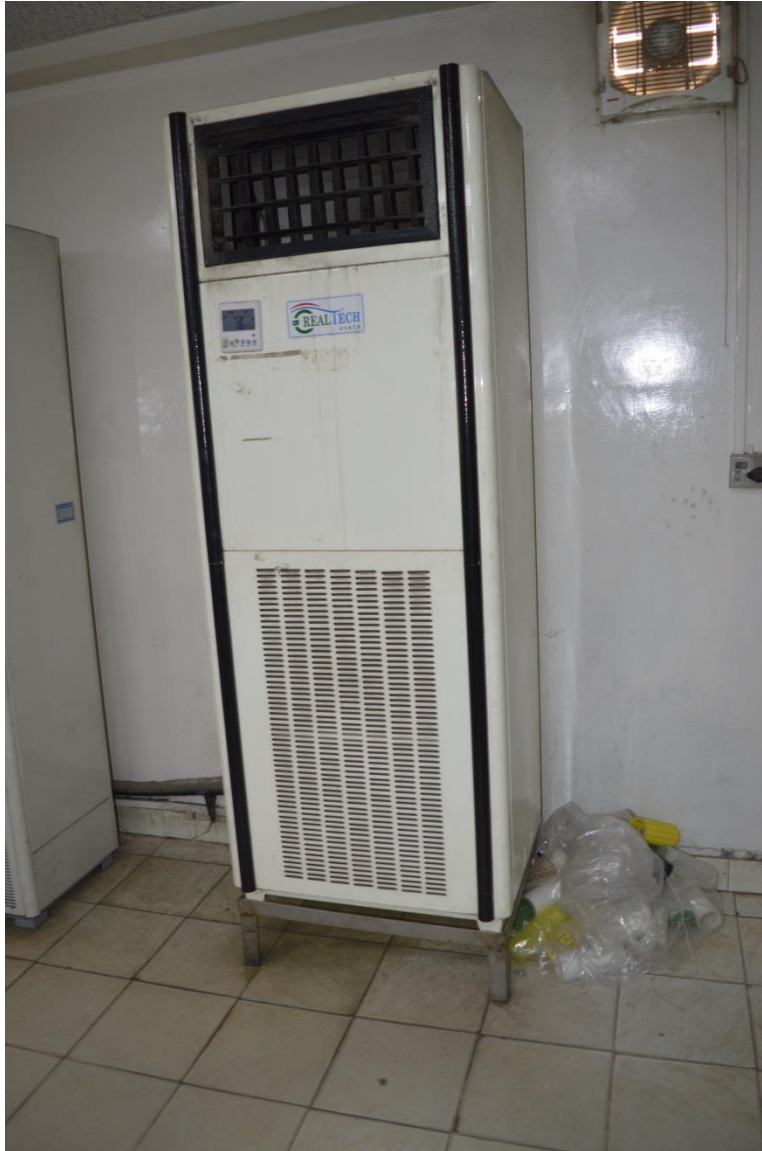
3. In general, emergency equipment, lighting fixtures, pipes and ducts were anchored properly.
4. In most cases equipment was properly anchored to the floors; however, in some cases, proper anchorage was found missing.

Figure 4: Air-conditioning equipment not anchored properly to the floor

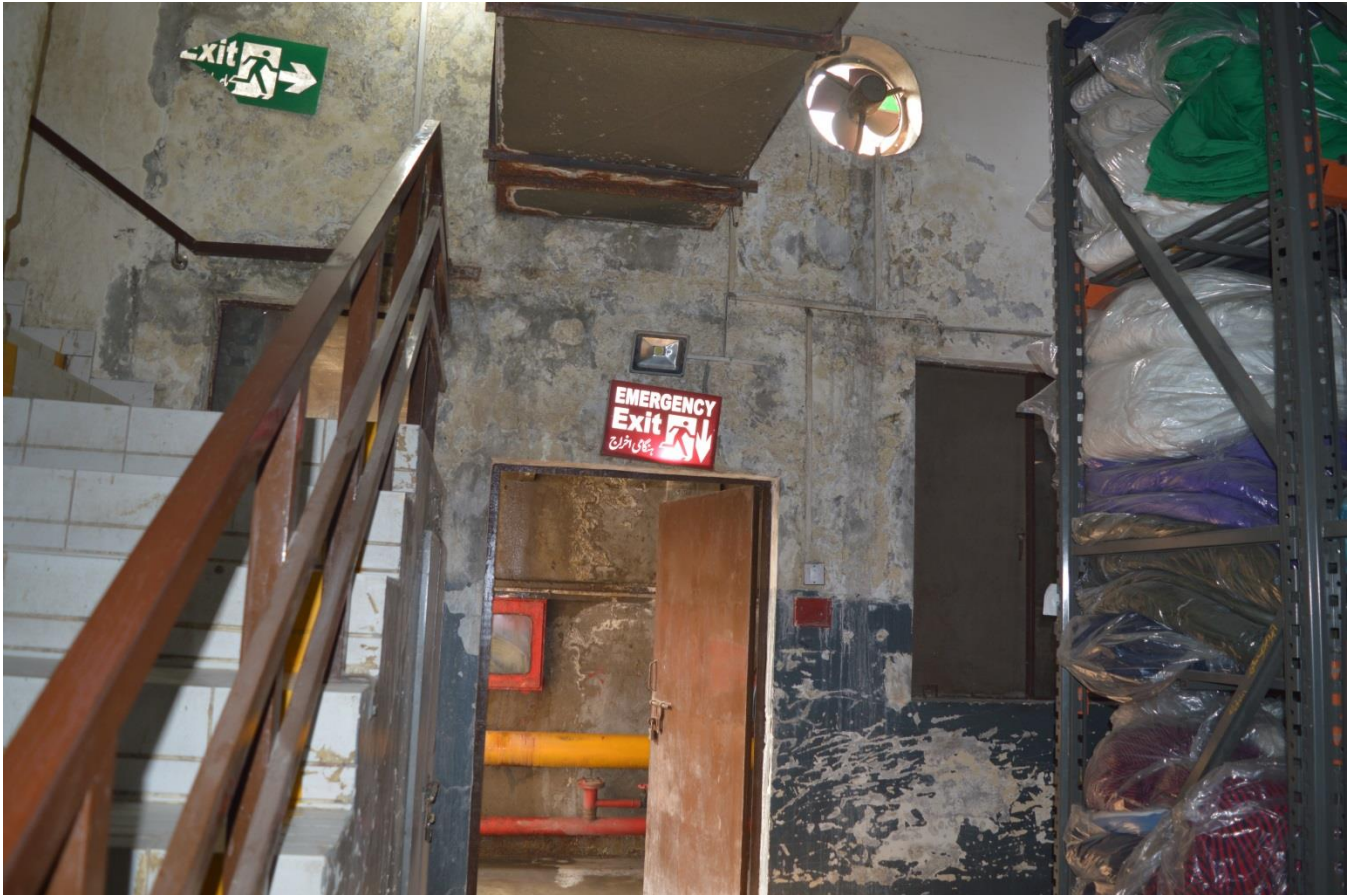
5. Seepage and deterioration in structural elements as well as masonry walls was found to be present.
6. Part-1 of the building does not satisfy the codified provisions corresponding to the Life Safety (LS) requirements in case of the following stipulated clauses.

Figure 5: Deterioration of masonry walls observed

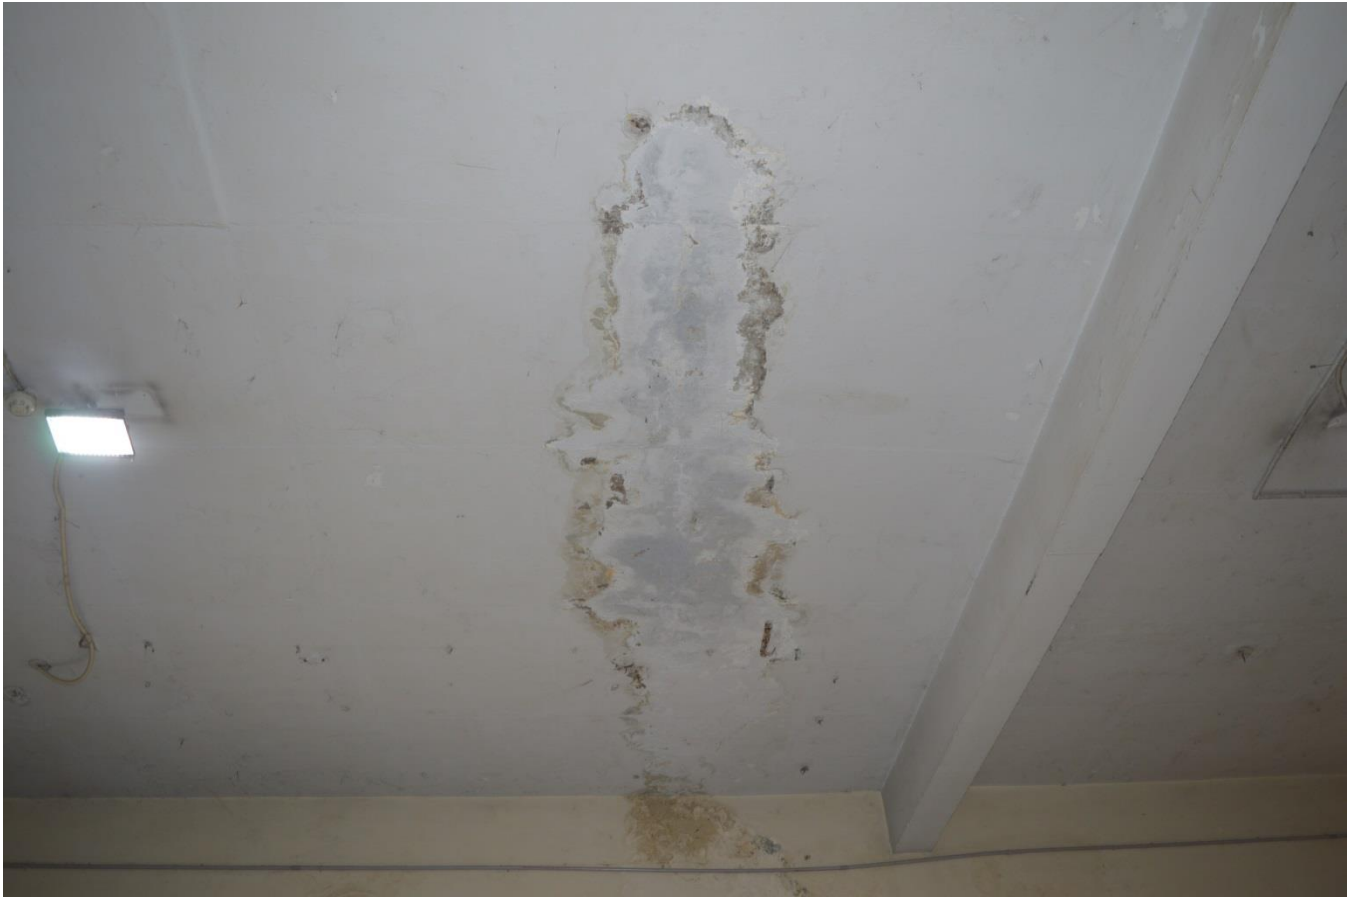
Figure 6: Seepage observed in the slabs

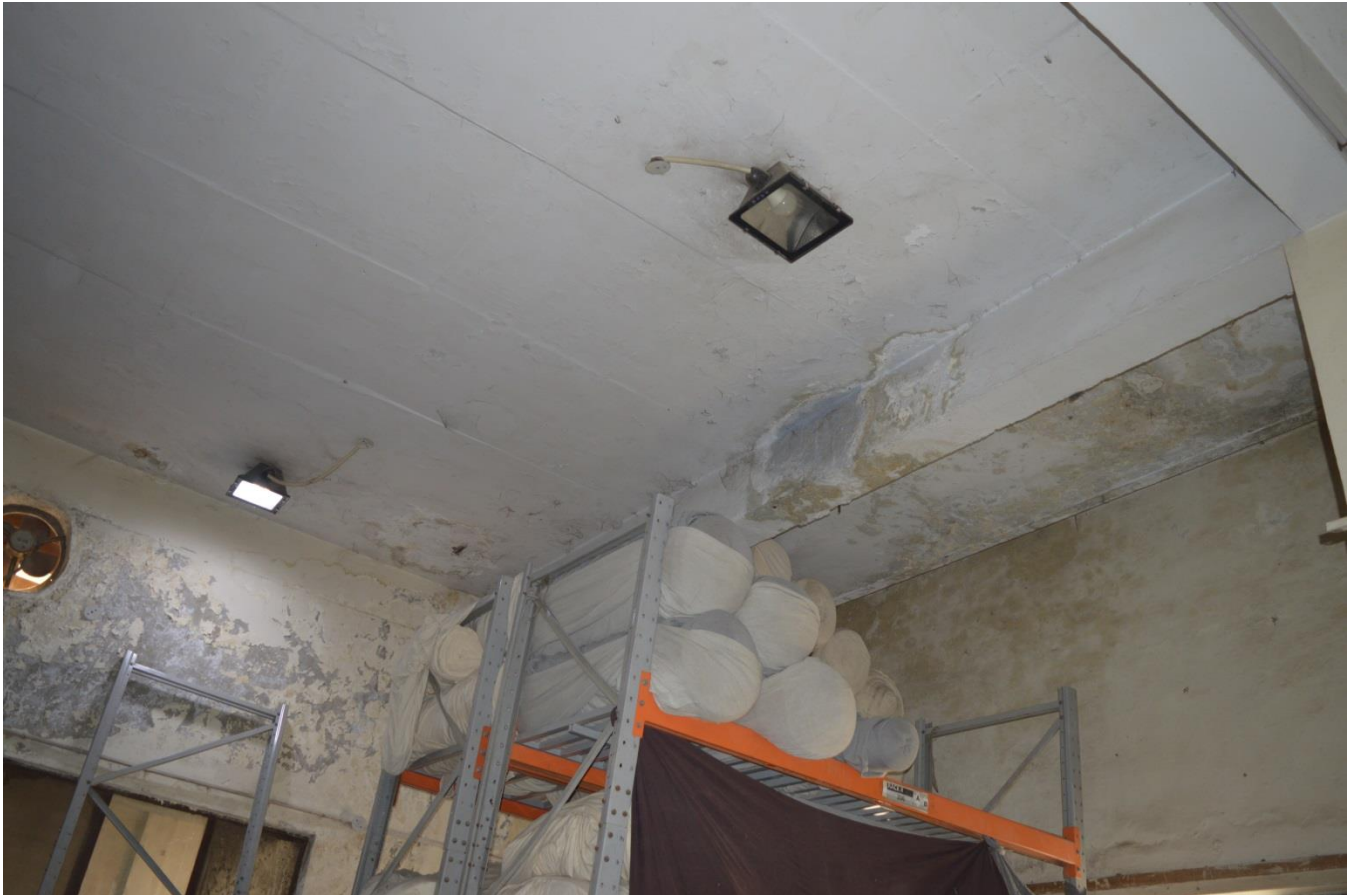
Figure 7: Seepage observed in the slab, beam and walls

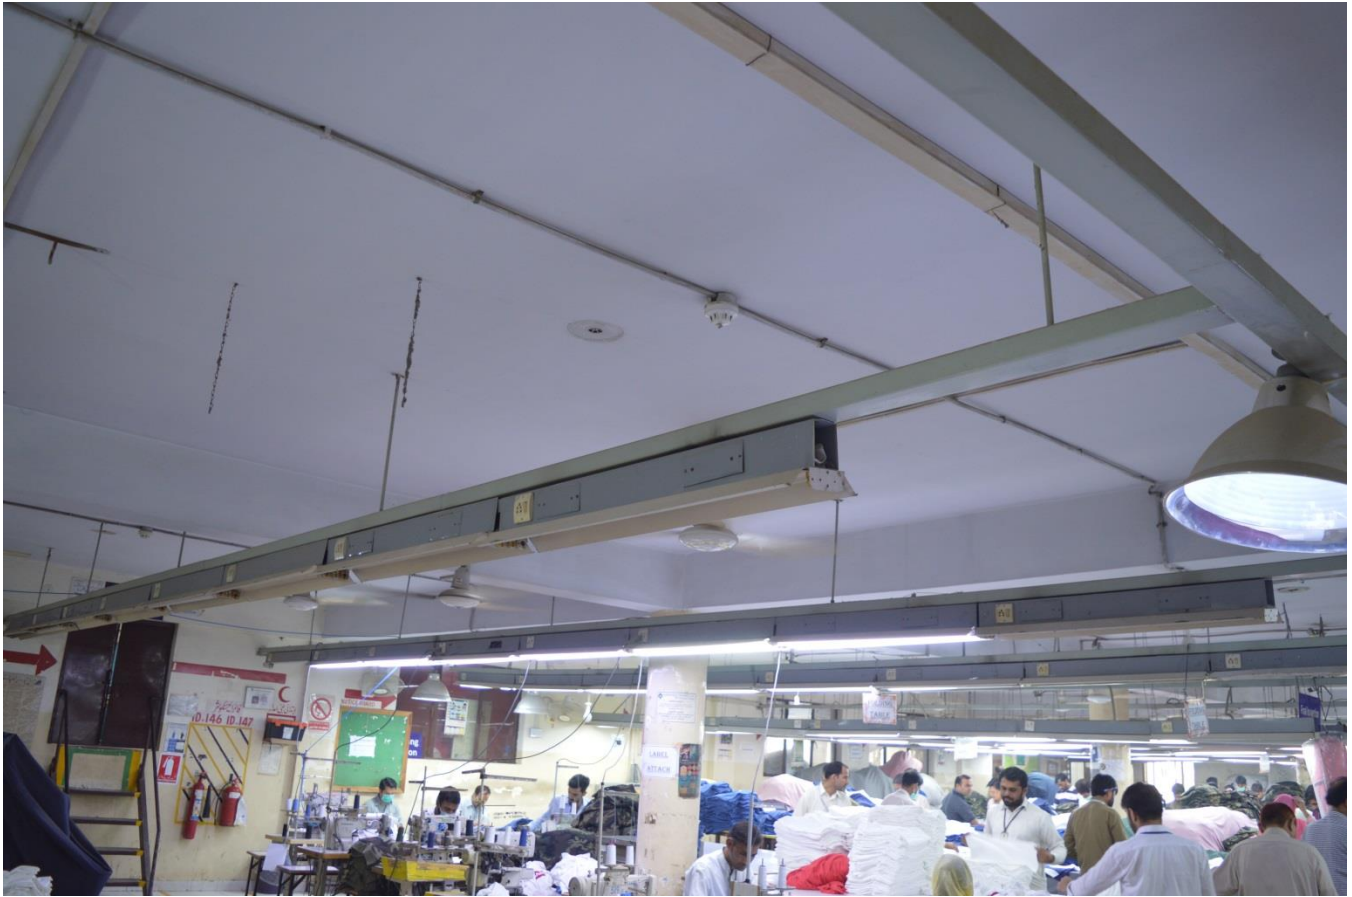
Figure 9: Lighting fixtures anchored properly
